Project Overview

Location: Texas City, TX

Application: 8" Hydrogen Pipeline

Repair System: FormaShield

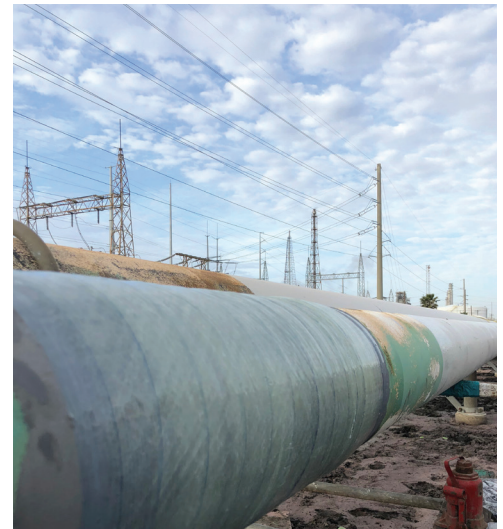
Completed FormaShield repair.

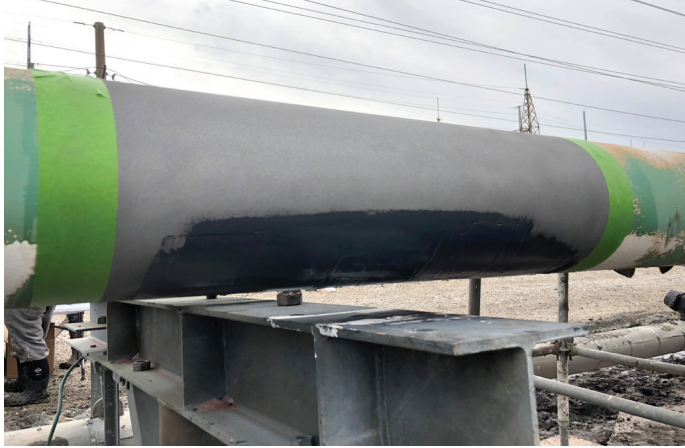
EP-420 filler material applied.

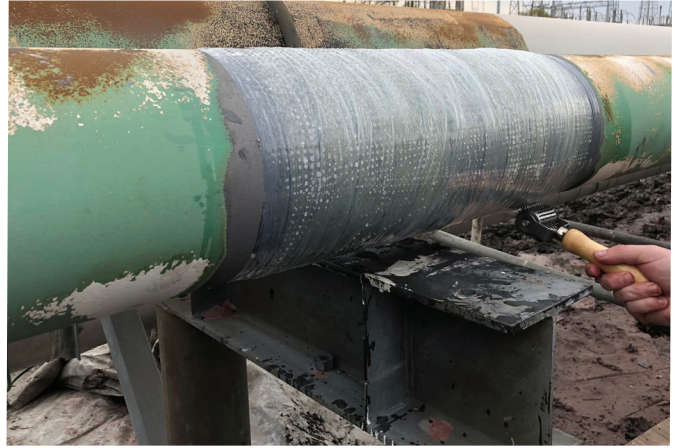
FormaShield installation in progress with perforating constrictor wrap.
