## Project Overview

A 20" OD horizontal natural gas pipeline in Patterson, LA that had been installed in 1956, was experiencing significant external Class 1 location corrosion. The damages, existing at 9 o'clock and 3 o'clock, were 17" long x 15" wide by x .123" deep for the 1st grid and 15" long x 16" wide x .066" deep for the 2nd grid, respectively. The repair of the pipe with a nominal wall thickness of .281" would require facilitating a maximum operating pressure of 1,050 psi and a pipe temperature of 50°F.

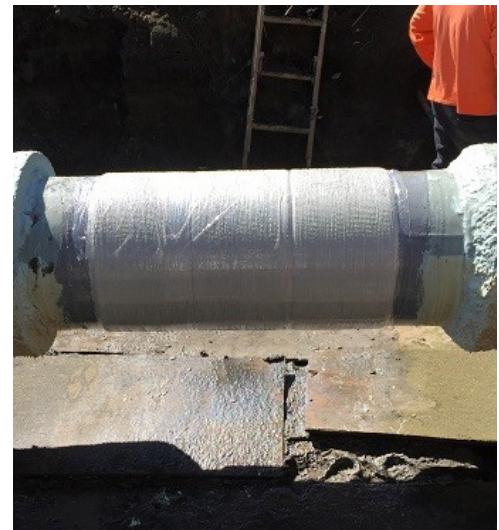
Completed A+ Wrap installation

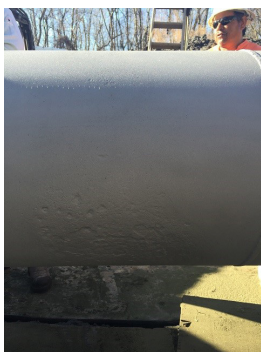
View of corrosion

The Pipe Wrap® team designed a 20-year life solution utilizing the A+ Wrap™ System. The system consisted of with 17 layers of A+ Wrap™ for three linear feet, which would restore the structural integrity of the pipeline and bring it back to pristine conditions based on the first grid.

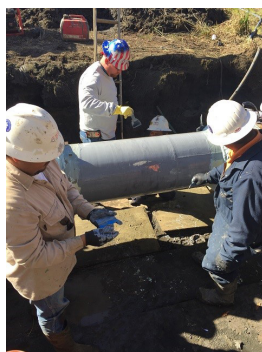
Application of PPR epoxy

The repair was completed in two hours by a Pipe Wrap technician and contractor personnel. The repair area was grit-blasted and wiped clean with Acetone followed by an application of EP420 as filler material for load transfer at corrosion. The repair included a girth weld and long seam welds. The technician then applied a PPR epoxy coating to entire repair zone. The 12" Wide A+ Wrap™ System was applied using the layer over layer with offset method. ILI markers were then installed to allow for inspection. The application was finished by applying Constrictor Wrap, which was perforated and allowed to cure. The next day the contractor removed the Constrictor Wrap and applied a tpoat with customer coating.

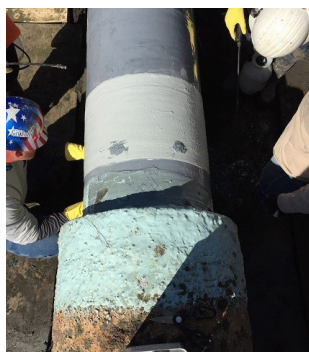
Installing ILI markers

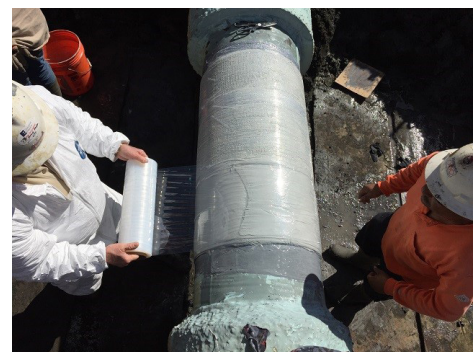
A+ Wrap installation with Constrictor Wrap
