# Pipe Wrap® RidgeBack™

## Active pipeline leak repair

### Project Overview

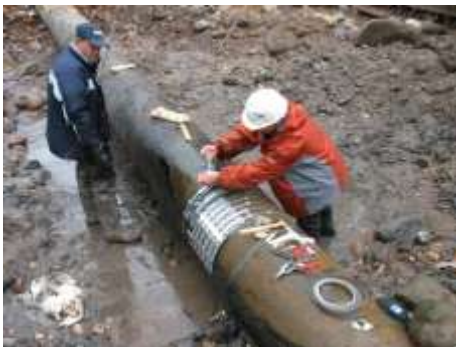
Installing the RidgeBack™ system

The product of choice for this type of active leak defect is the RidgeBack™ system, because a compression type seal is required that uniformly distributes the compressive forces thus minimizing the possibility of collapsing the pipe.

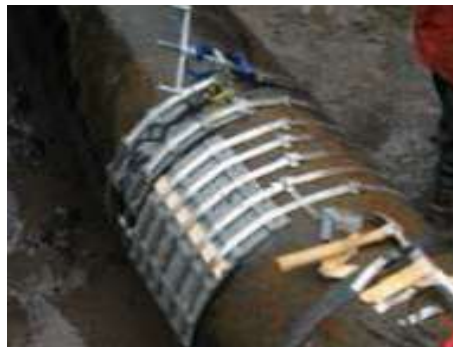
Close up of installed RidgeBack™ system

The end user was able to successfully repair their pipeline with the compressive forces of the RidgeBack™ system without collapsing the pipe. Additionally, the Pipe Wrap® system helped extend the life of the asset.

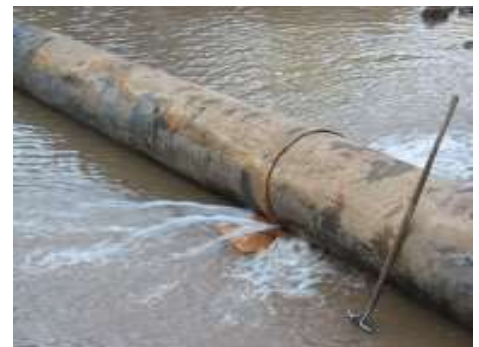
The operation of the line could not be interrupted due to the impact on the hatchery. The initial challenge was to divert the river to allow access to the pipe for remediation. Once the river was diverted, there were five (5) noticeable leaks from holes that ranged in size from 1" to 3" in width.

3" leak area
