Concrete Cloth™

Geosynthetic Cementitious Composite Mat

Project Overview

Channel Lining

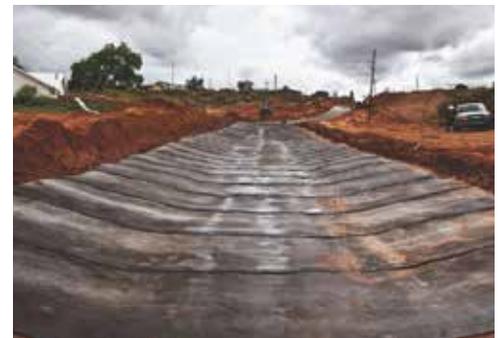
The entire 12,000 square feet of Concrete Cloth material was installed in one day, despite rainy conditions.

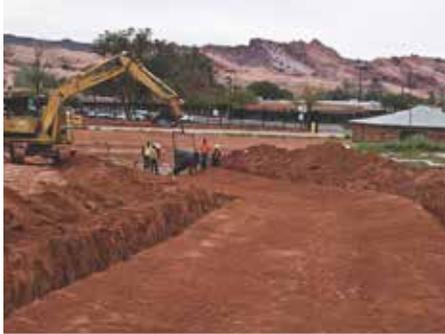
Pre-installation preparation

Before the start of the installation, heavy rain had caused significant erosion. The contractor had a significant amount of re-grading work not only at the location of channel 8, but across the project area. Directly at the location of Channel 8 the channel was graded and trenches were dug for burial of the outside edges of the Concrete Cloth material.

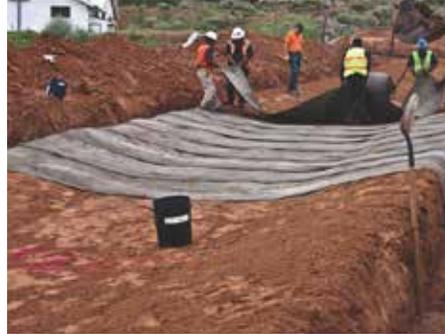
Laying the Concrete Cloth material

Ultimately, Concrete Cloth GCCM was chosen to line the channel and the outside edges were buried two feet deep so that the sheet flow of water perpendicular to the channel would not undermine the material.

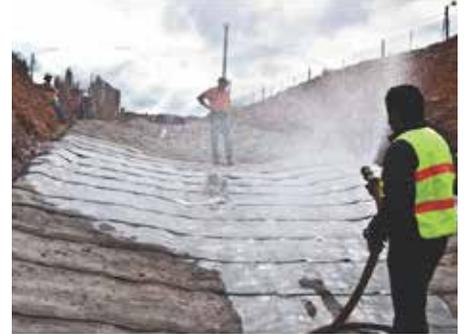
Hydrating the Concrete Cloth material
