Project Overview

Application: Brick Interceptor Sewer

Client: Detroit Water and Sewerage Department (DWSD)

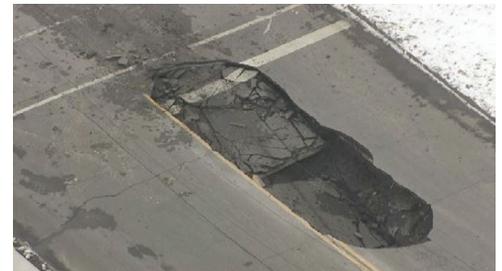
In May 2016, a massive sinkhole formed underneath Tireman Avenue in Detroit, Michigan. The root of the problem was a fractured sewer line. A damaged pipe leading to a major brick interceptor caused heavy infiltration, which in turn resulted in soil loss around the interceptor at the fractured location of the pipe. The soil loss eventually worked its way to the surface to create a 12-foot wide sinkhole, forcing the closure of Tireman Avenue and major public disruption. The pipe was directly below multiple utilities, including a 16-inch high-pressure gas main. If the interceptor totally failed, then the utilities were at risk of catastrophic damage.

Sinkhole on Tireman Avenue caused by damaged interceptor.

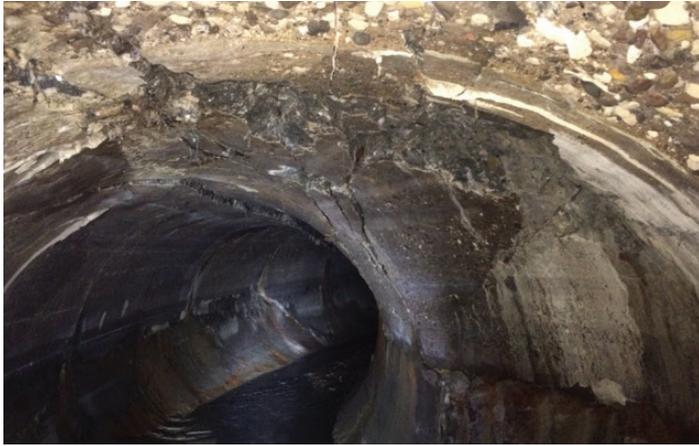
The 1930's design had the flow from the connection emptying near the crown of the interceptor, and this vertical drop created turbulence and ultimately the formation of H_2S gas, which ate away at the secondary liner. This corrosion was discovered when the sinkhole appeared, but had been corroding for decades.

Damaged and corroded sewer interceptor under Tireman Avenue.

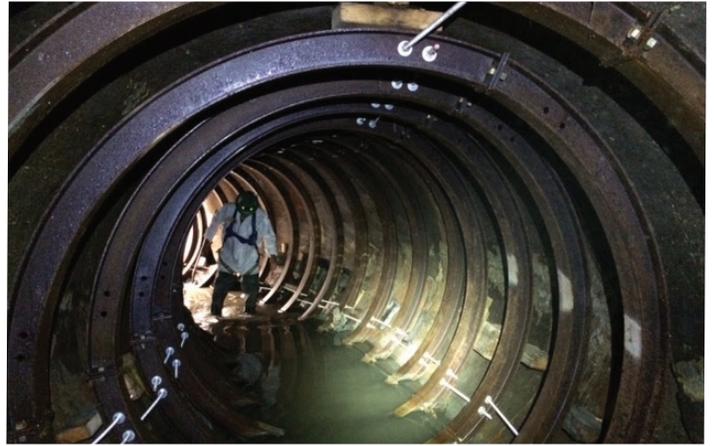
Lattice girders installed to shore up collapsed structure.

The straight section of the interceptor was repaired with a 78-inch HOBAS pipe. The curved portion of the interceptor, however, made it unsuitable for this type of rehabilitation. DWSD designed an alternative repair, which included the installation of steel lattice girder followed by the application of GeoSpray® geopolymer mortar as a preferred structural repair solution for this section of the project. When the area had been cleaned, relined and grouted, GeoSpray® mortar was sprayed onto the new ribs and lagging. Grade nails were installed to verify the specified 1.75-inch thickness required for the curved portion.

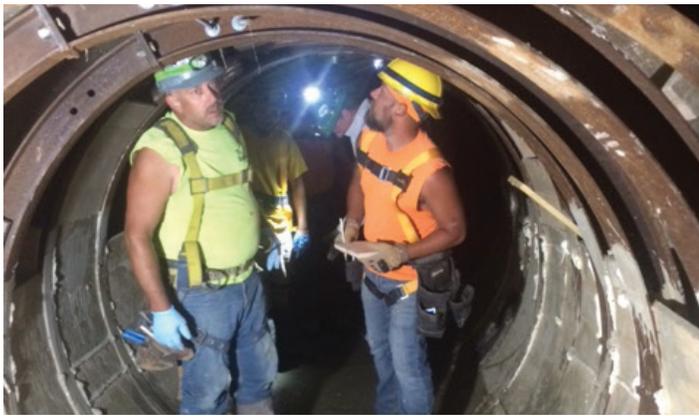
Grouting of annular space around and behind girders.

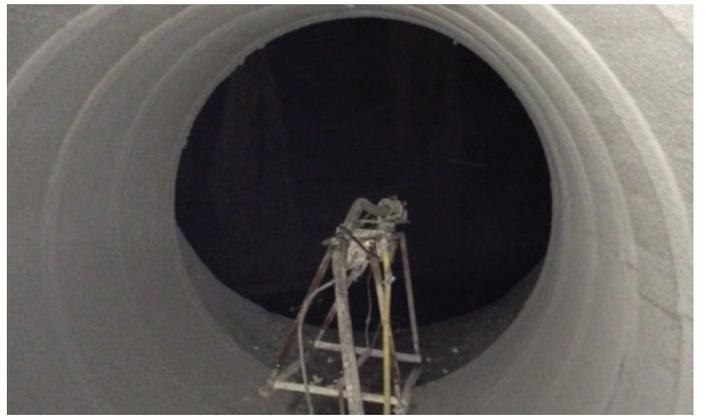
GeoSpray coating for strength and corrosion resistance over steel.

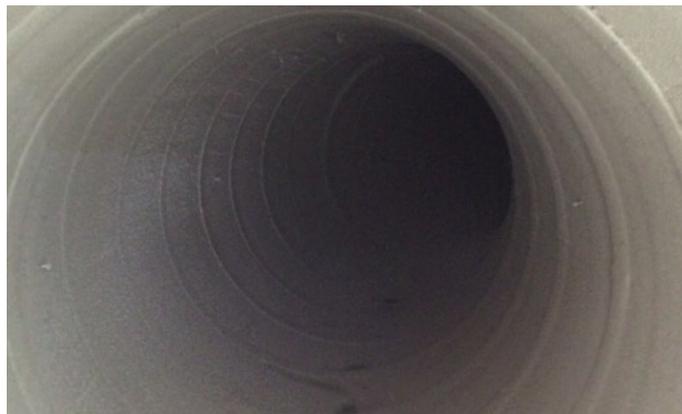
Completed rehab of curved section of interceptor.

The entire repair took six months from beginning to end, with final pavement replacement and the reopening of Tireman Avenue in November 2016, but a five-man crew took only five days to install the GeoSpray® portion of the repair. "Unlike traditional cement mortars, GeoSpray® is capable of bonding and building to great thicknesses," said Joseph Fattore, IWPC Senior Project Manager. DWSD inspected and approved of the entire repair, which included a drop manhole that eliminated any future H_2S issues within the sewer.
