# Concrete Cloth™

## Geosynthetic Cementitious Composite Mat

### Project Overview

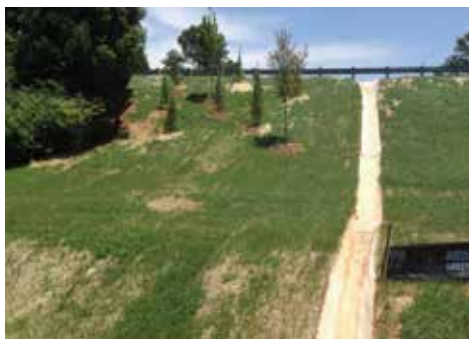
Positive aesthetics achieved with Concrete Cloth material

The photograph to the left shows the positive aesthetics achieved with Concrete Cloth GCCM.

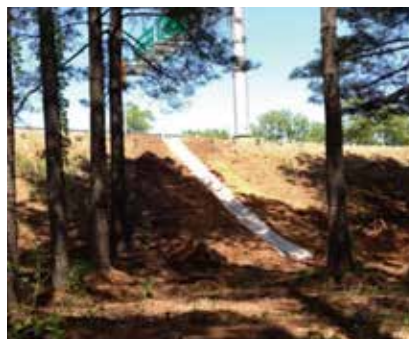
Concrete Cloth material installed pre-landscaping

Concrete Cloth material was used again for this project because of its flexibility to conform to the terrain, which made this an easy installation. The material can be installed by the earthmoving contractor with no subcontractors and is competitive against hot mix asphalt or cast-in-place concrete.

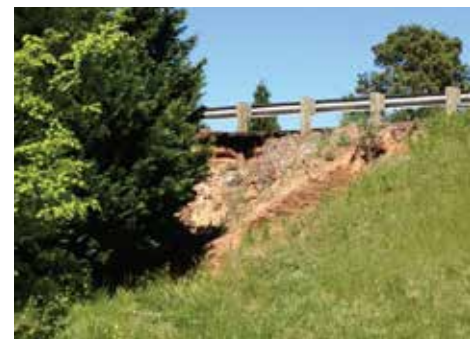
Severe slope erosion

When the SCDOT had severe erosion on a slope face of an overpass bridge on I-26 in Spartanburg County, they turned to a proven solution. Having already used Concrete Cloth material for a similar application, they knew its value. In both cases water coming off the bridge approach was running under a guardrail, then down the slope of the approach embankment causing erosion of the slope face. Concrete Cloth material was used to create a flared inlet to funnel the water to the flume or downslope swale. This created a structure similar to SCDOT Standard Drawings 403-205 and 403-210.
